Development Characteristics of a Coastal Slum Area in Indonesia: A Case Study of Fishermen Settlements in Muara Angke, North Jakarta

RATNAWATI YUNI SURYANDARI¹, LAILI FUJI WIDYAWATI¹

¹Department Urban and Regional Planning, Esa Unggul University, Jakarta, Indonesia

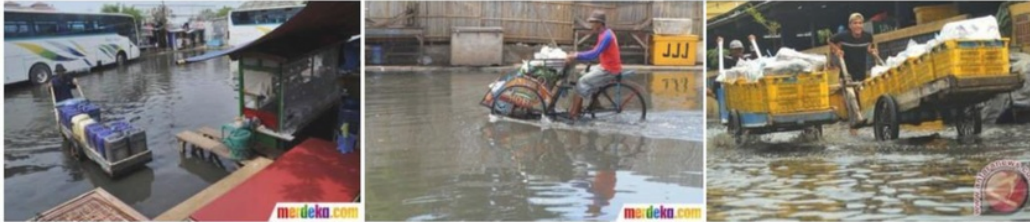
Picture 2. *The Condition during the Floods in Muara Angke*

The environmental conditions in Muara Angke is unhealthy. The area is relatively dense and dominated by houses made by flammable material which are very close to each other. When entering this area, there was also an unpleasant fishy odor resulted from the salting fish production. The area is lack of cleanliness as many piles of household garbage could be seen everywhere, including solid and liquid waste from salting fish. There ere puddles on the roads as the result of tidal floods and clogged and turbid drains. The household needs for clean water for cooking, bathing, washing and so forth are fulfilled by buying water from mobile water traders (Tiya, 2017).

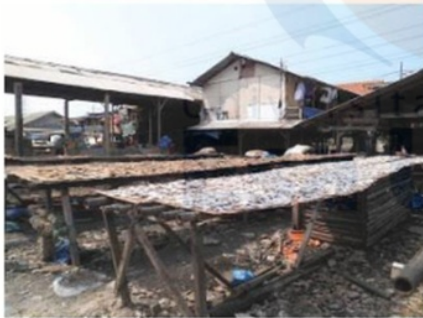
Housing around the salting location
Source: Anisa et al., 2018

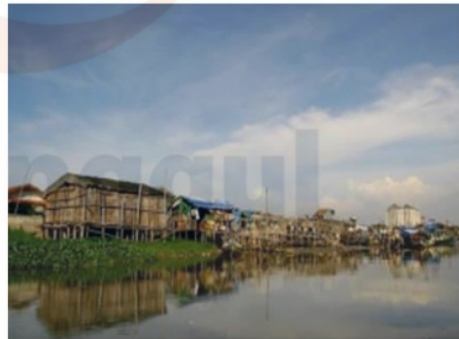
The other Muara Angke fishing villages are settlements with no legal permits and located in the river and coastal border areas. The settlements are housing with irregular inter-building locations and semi-permanent building quality. The houses are in quite level of density. In addition, the existing buildings did not take river border into consideration, even still the building was built by utilizing an empty river bank. This resulted in the emerge of slums area in several corners of Muara Angke (Kartika Putri, 2013). The last type of settlement requires a layout arrangement of the building to eliminate the slums in Muara Angke.

Settlements in river and coastal border areas
Source: Anisa et al., 2018

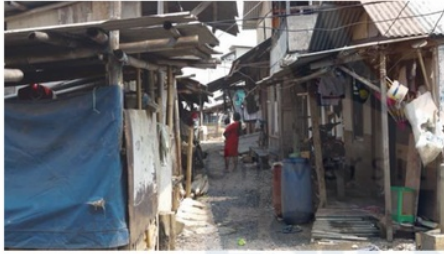
The condition of the connecting road between houses could only be passed by 2 people with a width of ± 120 cm. In addition, there are several roads in the settlement which are still in the form of land which are only piled up with debris from buildings with uneven contours. When it rains it, the roads often becomes a pool of water (Anisa, et al., 2018).

Conditions for connecting roads between houses
Source: Kumparan.com, 2017

- 2) The condition of the connecting road between houses which can only be passed by 2 people with a width of ± 120 cm. In addition, there are several roads in the settlement that are still in the form of land which are only piled up with debris from buildings with uneven contours so that when it rains it often becomes a pool of water (Anisa et al., 2018).

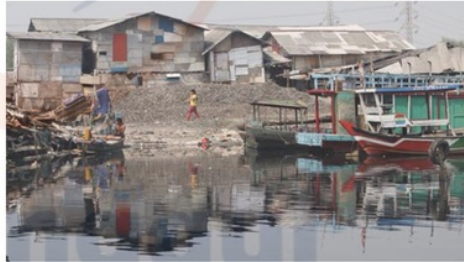
Settlements in the coastal border
Source: Kumparan.com, 2017

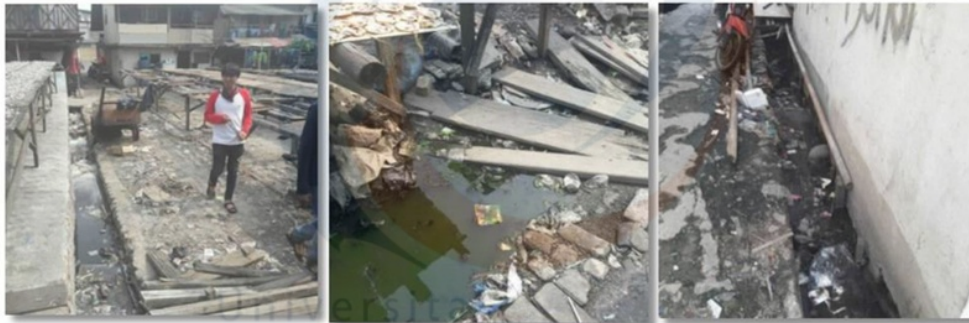
Picture 4. *Drainage Condition in Muara Angke*

Poor drainage conditions, starting from the residential areas to the drainage at the salting fish production are not well-integrated to the main waterways. People living there are also lack of caring when they process or dispose the processed fish waste which could pollute the drainage. Drainage in residential areas is also very small, ± 30 cm wide with a depth of ± 30 cm, which is less able to accommodate all community activities, added to the large amount of mud deposits and the amount of waste which makes drainage less functioning properly (Anisa, et al., 2018).

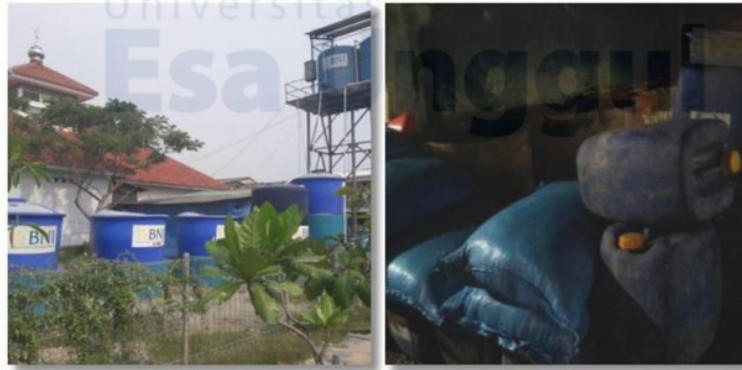
Picture 5. Clean Water in Muara Angke

According to Anisa, et al. (2018), for the need of clean water in the salting fish processing settlements, they still use water from PAM and well water. Residents are very dependent on PAM water due to the fact that well water in Muara Angke is actually very close to the sea so it is contaminated with salt water that is unsuitable to be used for the daily needs of residents. In the fish processing settlements, there are also several

public toilets as the source of clean water which people usually use to wash and bathe. Although there is a new water treatment plant built by the private sector, it is not considered sufficient for residents due to the coverage is still small. So many people who do not get clean water must buy clean water through small containers.
