## **Development Characteristics of a Coastal Slum Area in Indonesia: A Case Study of Fishermen Settlements in Muara Angke, North Jakarta**

### **Abstract**

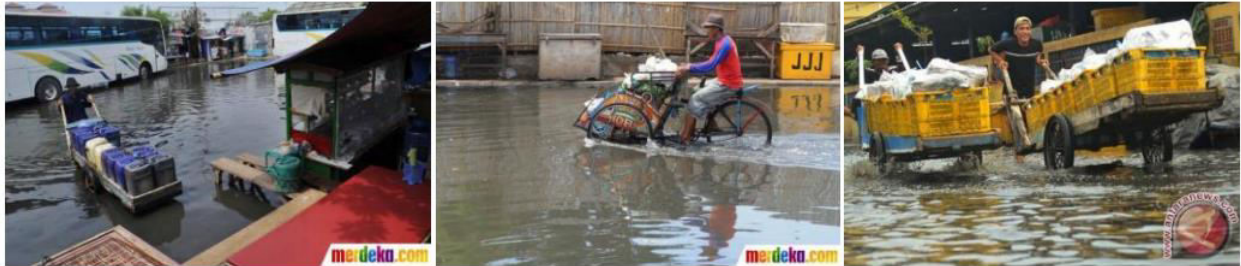
**Picture 2.** *The Condition during the Floods in Muara Angke*

The condition of the connecting road between houses could only be passed by 2 people with a width of ± 120 cm. In addition, there are several roads in the settlement which are still in the form of land which are only piled up with debris from buildings with uneven contours. When it rains it, the roads often becomes a pool of water (Anisa, et al., 2018).

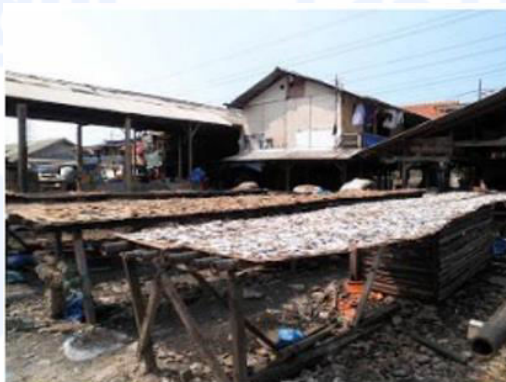
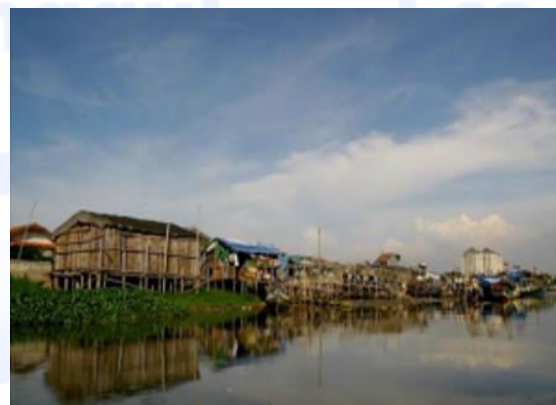
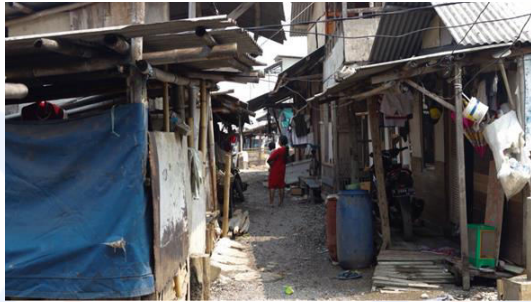
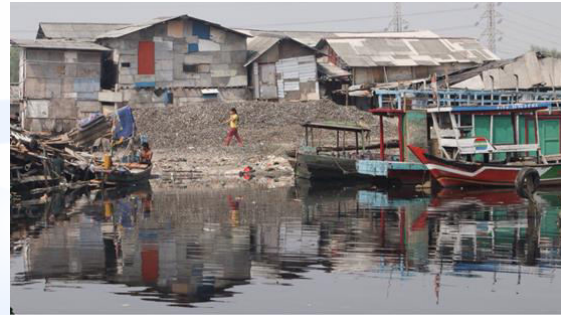
**Picture 3.** *The Fishermen Housing Condition of Muara Angke*

The other Muara Angke fishing villages are settlements with no legal permits and located in the river and coastal border areas. The settlements are housing with irregular inter-building locations and semi-permanent building quality. The houses are in quite level of density. In addition, the existing buildings did not take river border into consideration, even still the building was built by utilizing an empty river bank. This resulted in the emerge of slums area in several corners of Muara Angke (Kartika Putri, 2013). The last type of settlement requires a layout arrangement of the building to eliminate the slums in Muara Angke.

Housing around the salting location  
Source: Anisa et al., 2018

Settlements in river and coastal border areas  
Source: Anisa et al., 2018

Conditions for connecting roads between houses  
Source: Kumparan.com, 2017

Settlements in the coastal border  
Source: Kumparan.com, 2017

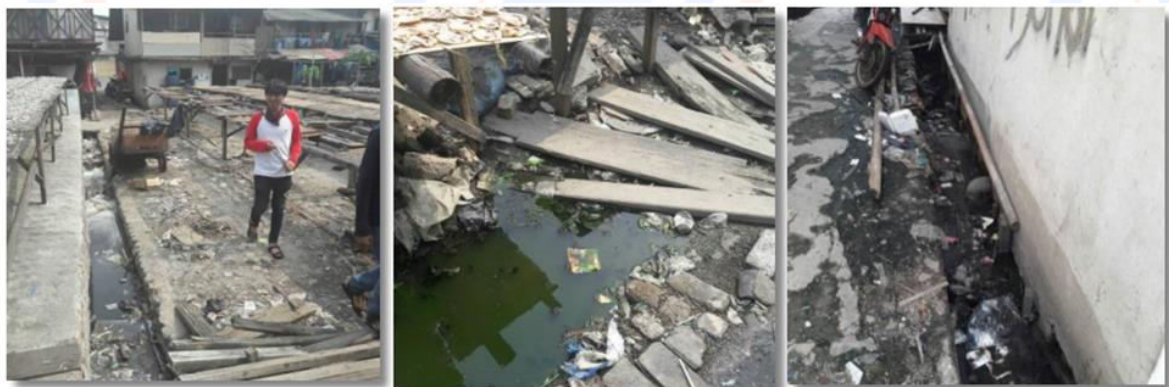
**Picture 4.** *Drainage Condition in Muara Angke*

Poor drainage conditions, starting from the residential areas to the drainage at the salting fish production are not well-integrated to the main waterways. People living there are also lack of caring when they process or dispose the processed fish waste which could pollute the drainage. Drainage in residential areas is also very small,  $\pm 30$  cm wide with a depth of  $\pm 30$  cm, which is less able to accommodate all community activities, added to the large amount of mud deposits and the amount of waste which makes drainage less functioning properly (Anisa, et al., 2018).

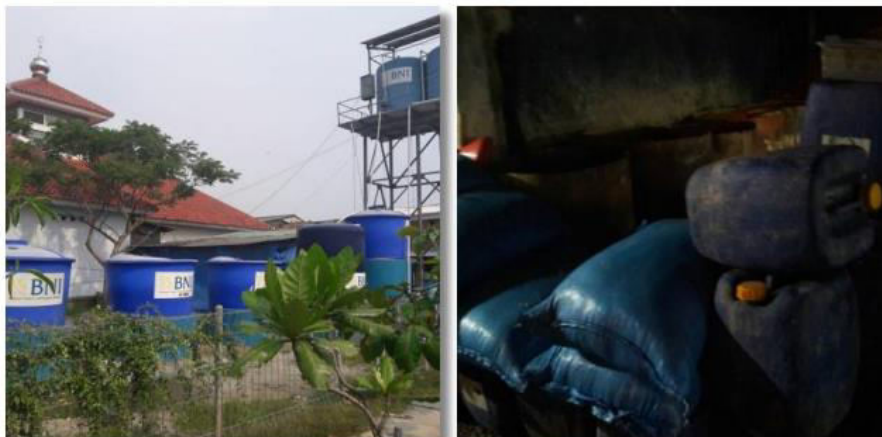
**Picture 5.** Clean Water in Muara Angke

According to Anisa, et al. (2018), for the need of clean water in the salting fish processing settlements, they still use water from PAM and well water. Residents are very dependent on PAM water due to the fact that well water in Muara Angke is actually very close to the sea so it is contaminated with salt water that is unsuitable to be used for the daily needs of residents. In the fish processing settlements, there are also several

public toilets as the source of clean water which people usually use to wash and bathe. Although there is a new water treatment plant built by the private sector, it is not considered sufficient for residents due to the coverage is still small. So many people who do not get clean water must buy clean water through small containers.
